AFFDL-TR-79-3118  
Volume III

DURABILITY METHODS DEVELOPMENT  
VOLUME III  
STRUCTURAL DURABILITY SURVEY:  
STATE-OF-THE-ART ASSESSMENT

B. J. PENDLEY  
S. P. HENSLEE  
S. D. MANNING  
GENERAL DYNAMICS CORPORATION  
STRUCTURAL AND DESIGN DEPARTMENT  
FORT WORTH DIVISION  
FORT WORTH, TEXAS

TECHNICAL REPORT AFFDL-TR-79-3118, VOL. III

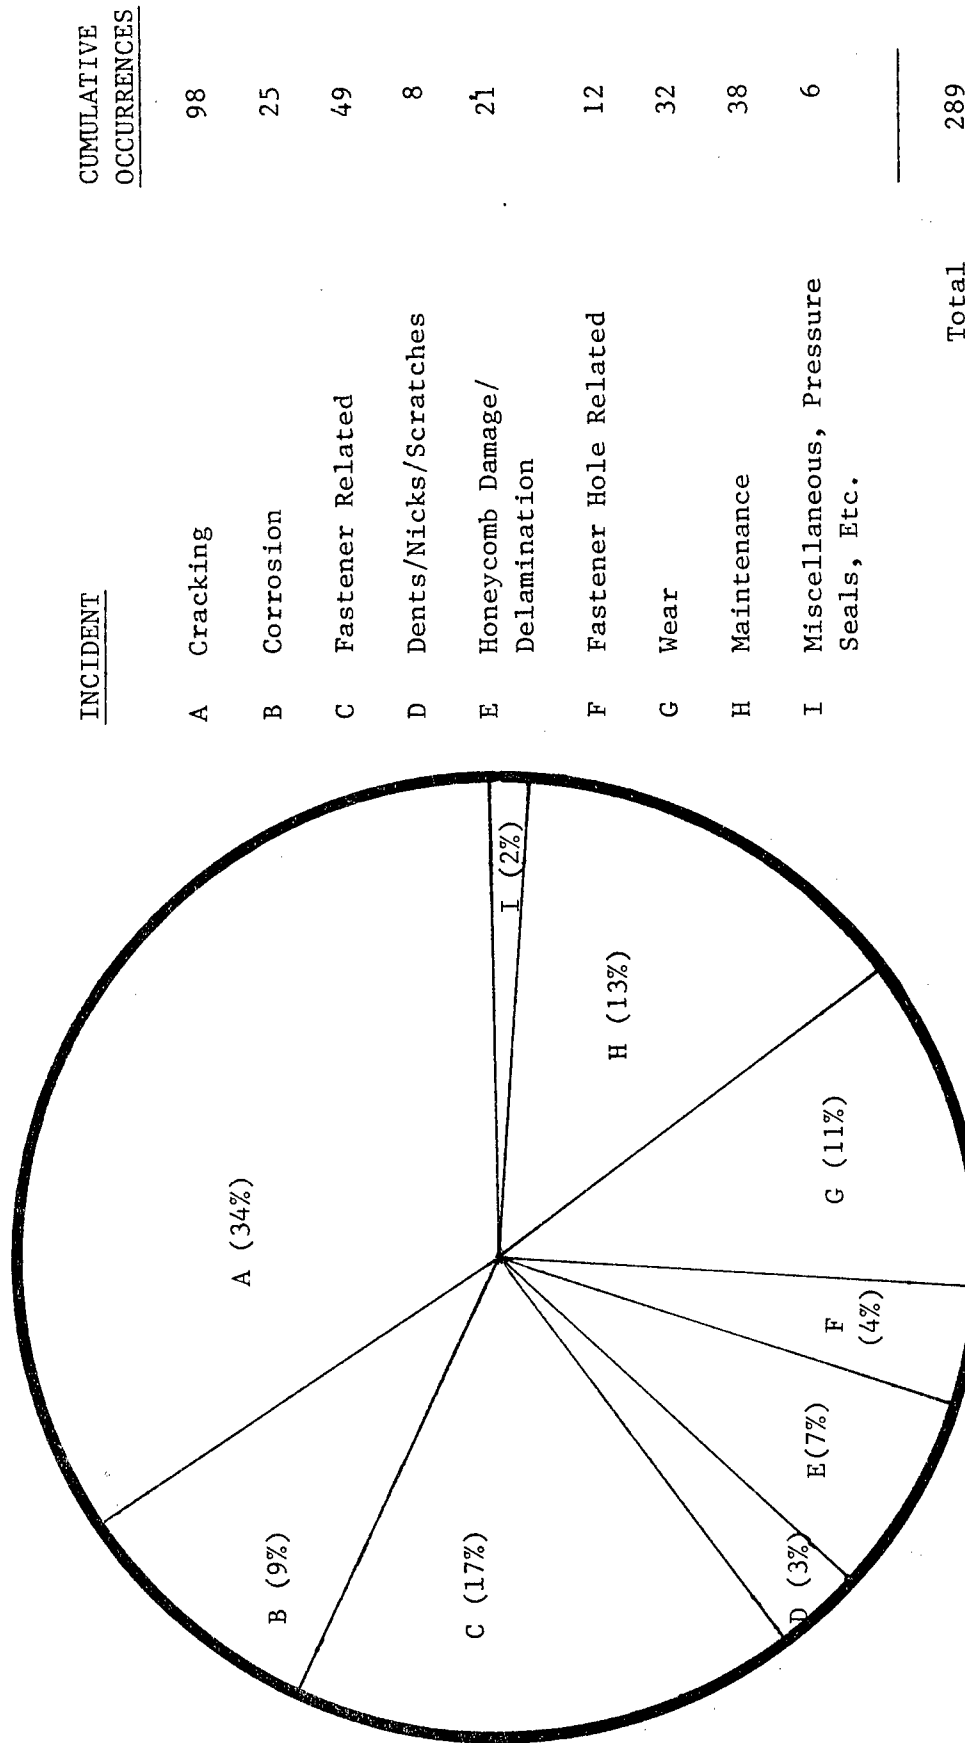
Figure 55 C-5A Analytical Condition Inspection Cumulative Occurrences for CY76 and CY77

Analytical Condition Inspection results for the C-5A transports are shown in Figure 55. Of interest here are the number of fastener-related and honeycomb-related problems. The high occurrence of honeycomb delaminations is to be expected since aircraft of this type use, on a percentage basis, more structural honeycomb.

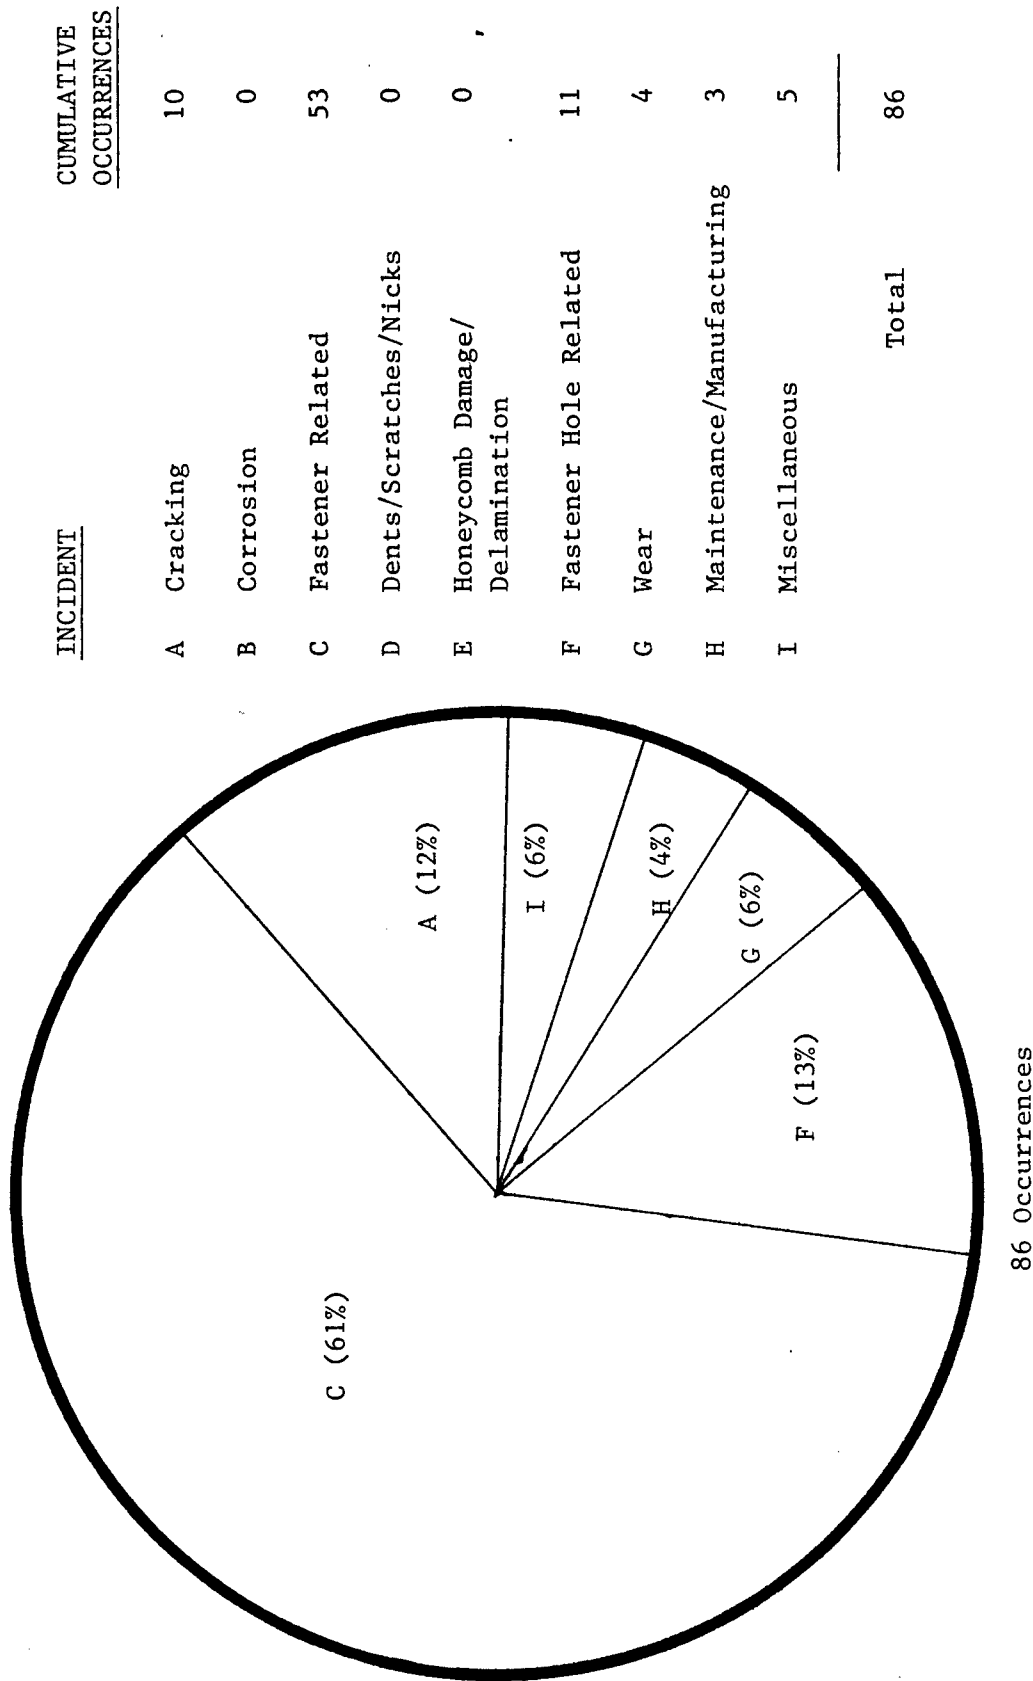
Figure 56 F-15A Analytical Condition Inspection

The F-15A ACI results, shown in Figure 56 do not reflect any trends, to be established later, seen in the aforementioned systems. This particular aircraft, the youngest fully deployed system in the Air Force inventory, is representative of state-of-the-art design and materials technology. The combination of age and technology yields the low or non-existent percentages in all categories other than fastener related. This particular ACI has a limited data base and therefore is not included in the following trends.

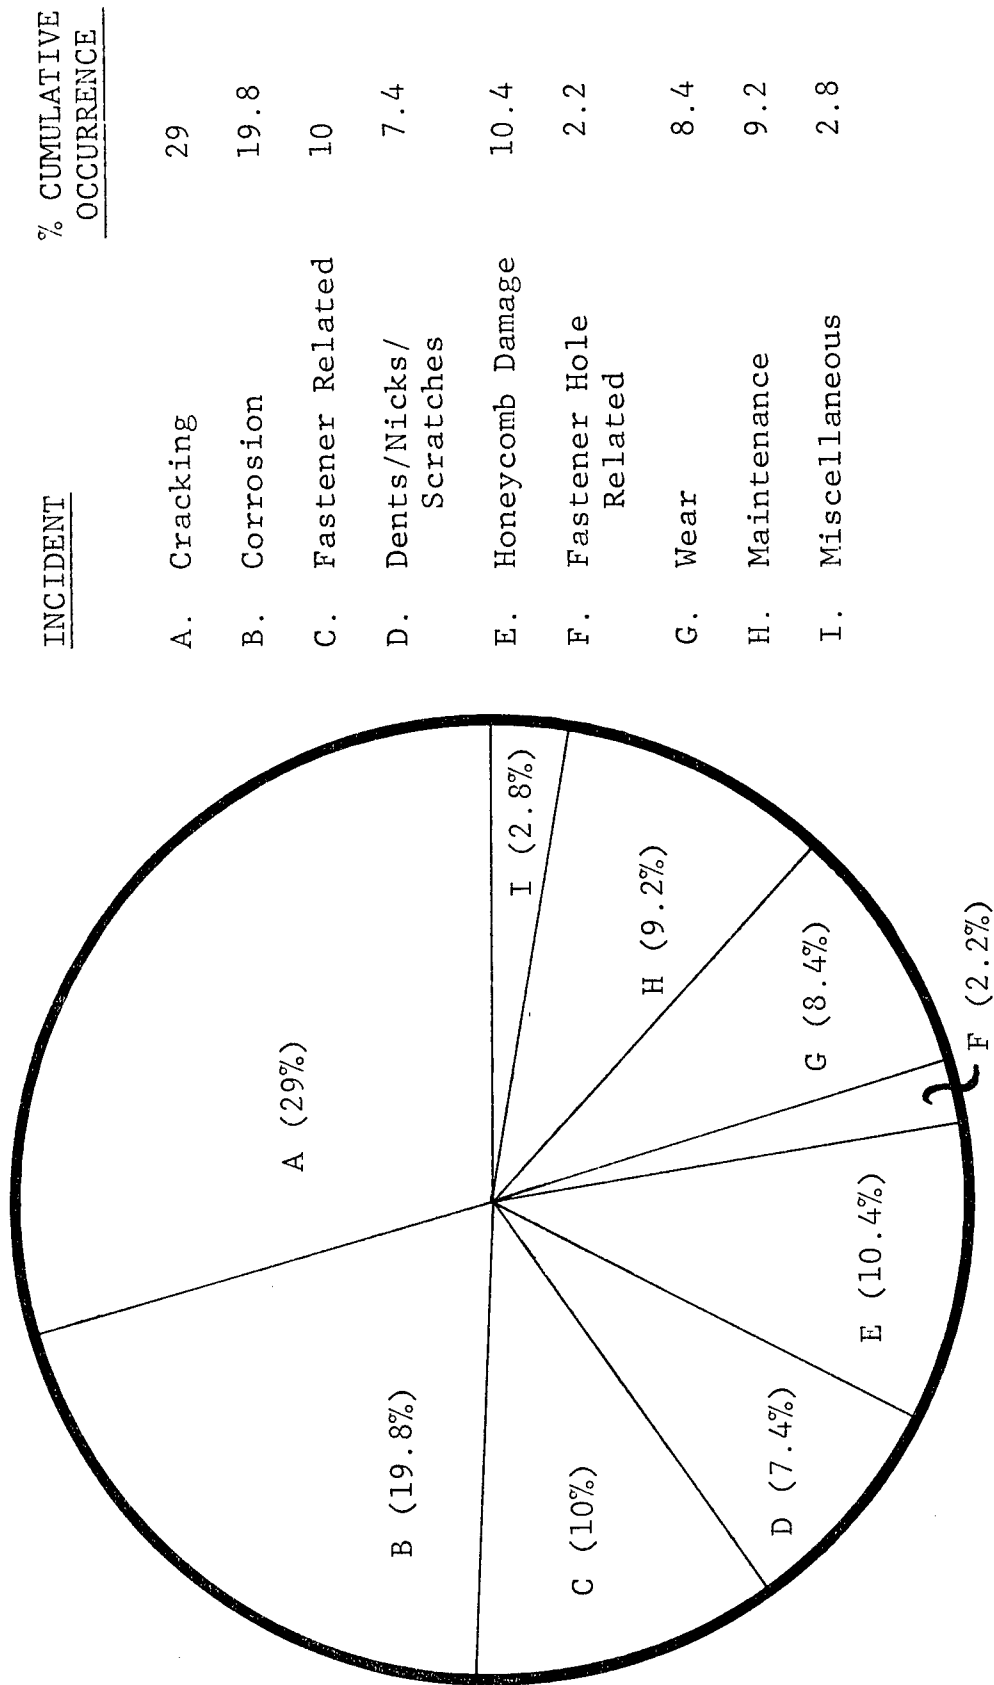
Figure 57 Average Cumulative Distribution by Percentage of Incidents from ACI for T-39A, F-4C/D/E, RF-4C, F-111, F-111C, and C-5A Systems.

The results shown in Figures 51 through 56 are combined into one composite figure, as shown in Figure 57. The average frequency of occurrence for a given incident during any inspection are noted. The numerical ranking of incidents is as follows:

1. Cracking
2. Corrosion
3. Maintenance
4. Fastener Related
5. Dents/Nicks/Scratches
6. Wear
7. Miscellaneous
8. Honeycomb Delaminates/Damage
9. Fastener Hole Related
